Release Notes

hp StorageWorks Multi-protocol Router XPath OS Version 7.1.2c

Third Edition (October 2004)

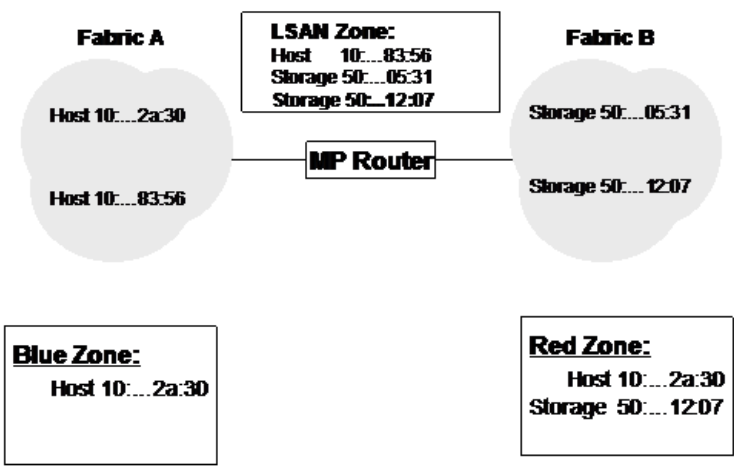
<p>The diagram illustrates a valid MP Router LSAN/local zone configuration. It features two fabric clouds, Fabric A and Fabric B, connected by an MP Router. Fabric A contains two hosts: Host 10:...2a:30 and Host 10:...83:56. Fabric B contains two storage units: Storage 50:...05:31 and Storage 50:...12:07. A central box labeled 'LSAN Zone:' lists the Host 10:...83:56, Storage 50:...05:31, and Storage 50:...12:07. Below Fabric A is a box labeled 'Blue Zone:' containing Host 10:...2a:30. Below Fabric B is a box labeled 'Red Zone:' containing Host 10:...2a:30 and Storage 50:...12:07.</p> <p>Figure 1: Valid MP Router LSAN/local zone configuration example</p>

Issue	Description
Unexpected "LSAN Zone Update" messages or "unexpected physical device offline" messages	<p>These messages can occur during normal operation. However, if the MP Router reports numerous occurrences that cannot be correlated to actual initiated events, such as planned device reconfigurations or re-boots, examine low-level port error counts using the <code>portstatsshow</code> command.</p> <p>Faulty cables and SFPs that cause interruptions in EX_Port connectivity might also cause unexpected fabric reconfigurations. In the event of unexpected fabric reconfigurations, ensure that there are no low-level errors occurring on ports, and focus diagnostic efforts on cables and SFPs.</p>
Zoning Restrictions for LSAN Zones and Local Fabric Zones	<p>Remote WWNs cannot be in both a Logical Storage Area Network (LSAN) zone and a local fabric zone of fabrics that they do not physically reside in. Putting them in both locations, may result in excessive boot times for host or servers in fabrics connected to the MP Router.</p> <p>If a remote node WWN is in an LSAN zone, then it cannot also be in a local non-LSAN zone in a fabric that it does not physically reside in. For example, if you have a host or storage device defined in a remote fabric zone and you wish to add either of these devices to an LSAN zone, you need to ensure that these devices are not listed in any local zones other than the physical fabric they reside in. Local WWNs are allowed in both an LSAN zone and the local zones of the fabric where they are physically located. (See Figure 1.)</p>

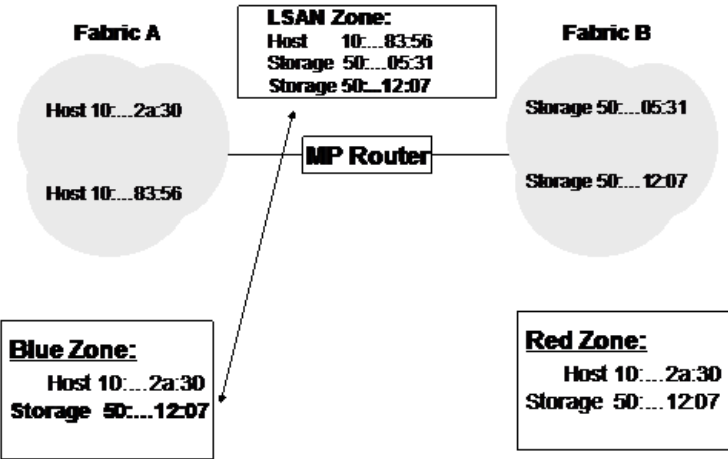
Issue	Description
	<p>Figure 2 shows an invalid zoning configuration because Storage 50:... 12:07 is located in both the LSAN zone and Fabric A Blue Zone, and the device is not physically located in Fabric A.</p>

<p>Figure 2: Invalid MP Router LSAN/local zone configuration example</p>
HP-UX device file names/FCID persistence	<p>In a configuration with multiple MP Routers connected in parallel between two fabrics, if the MP Routers are powered off and on, the translated Fibre Channel Address IDs (FCIDs) may change (depending on the sequence of which Router comes up first) as seen by the hosts in an LSAN zone.</p> <p>Since the HP-UX device file names are dependent upon the FCIDs, the device file names also change whenever the FCIDs change. Hence, any applications dependent upon the device file names will need to be reconfigured and the hosts may be required to be rebooted to ensure access to the devices.</p> <p>Workaround: Do not power-off all the MP Routers at the same time. If the MP Routers are inadvertently powered off and the initial power-on sequence is known, power up the MP Routers based on the initial power-on sequence; the FCIDs will be correct.</p>
